Photos made by the international investigator's group, by the OSCE members and by journalist in site. Many persons, few photos.

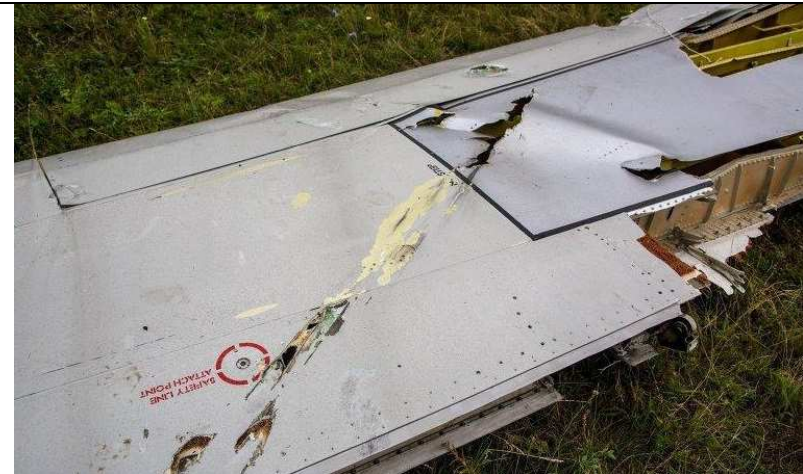
Left wing of the MH17 plane

Its completely impossible that BUK-M1 munition is doing that

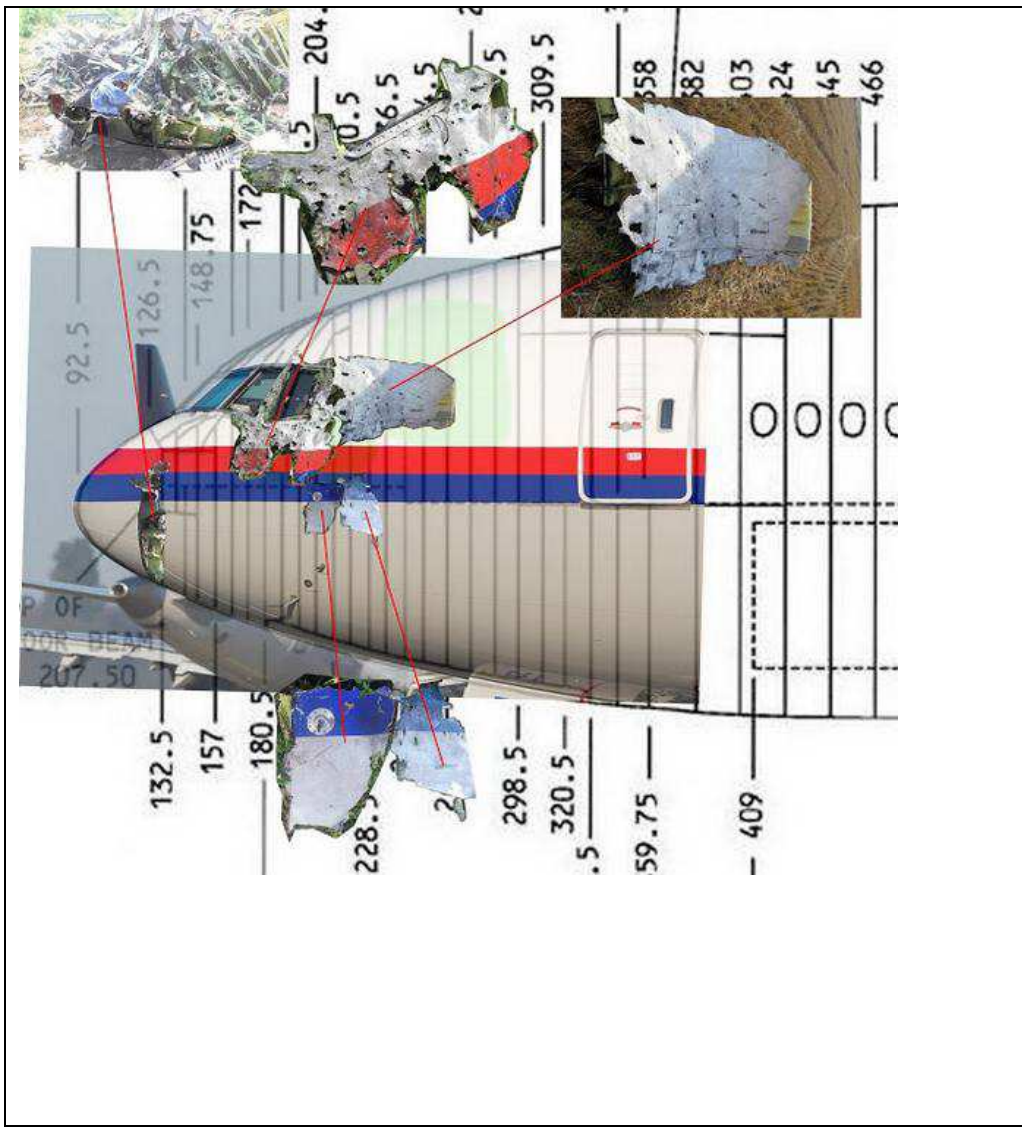
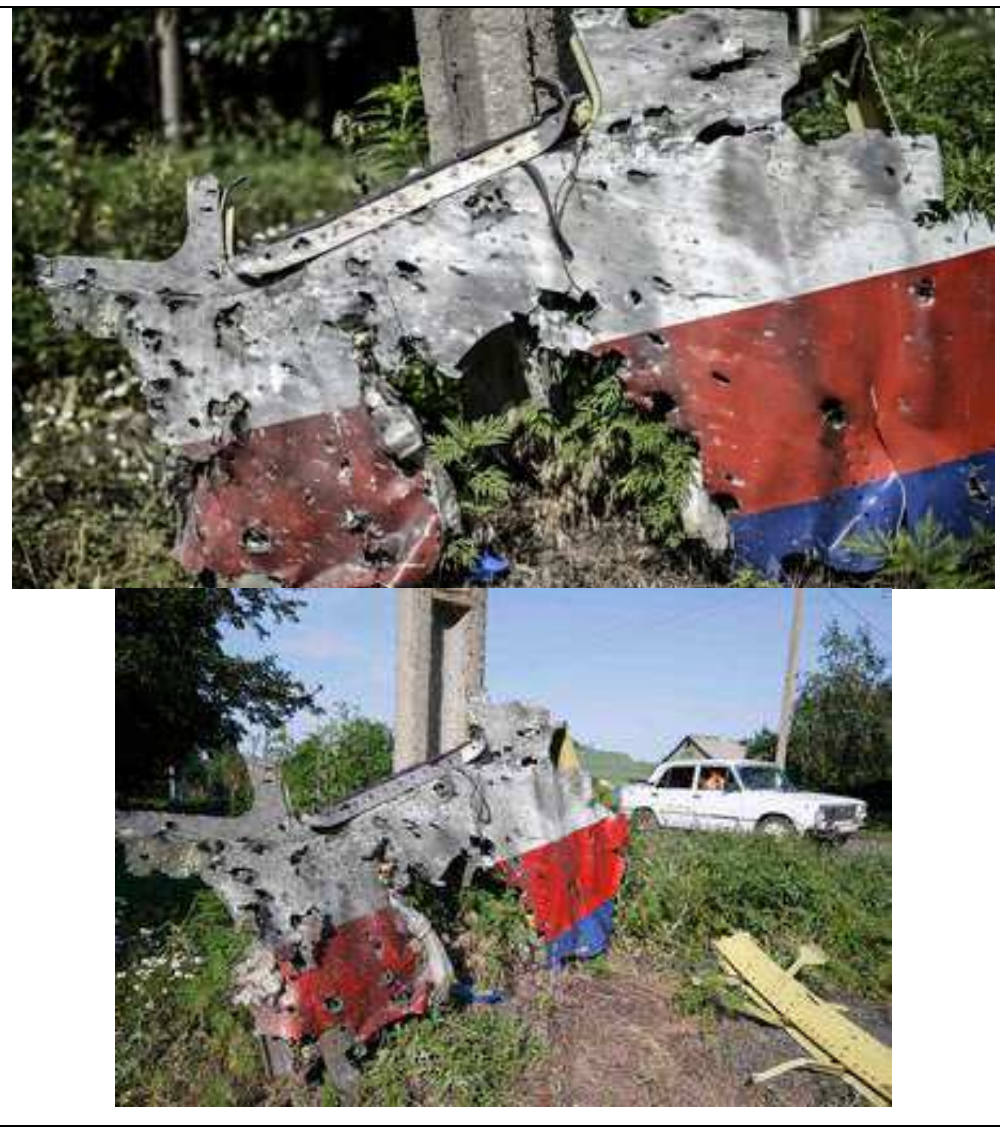
Ballholes in one direction – parallel impacts ?

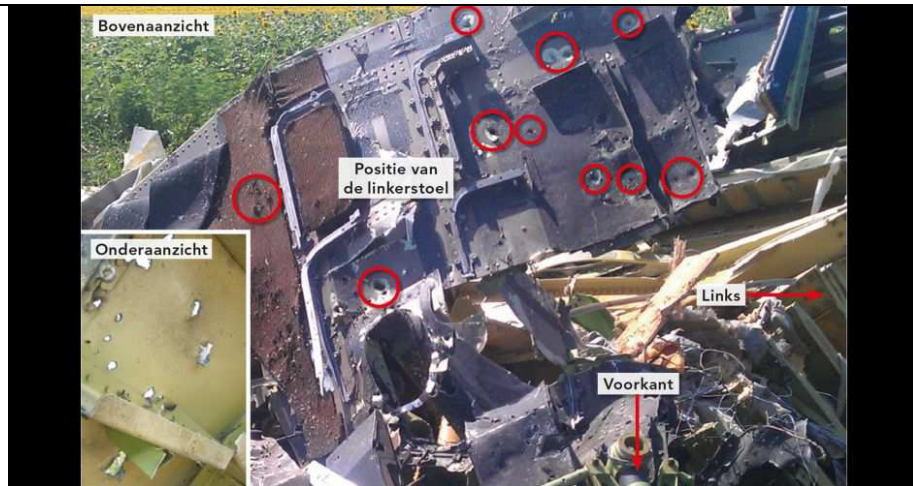
The cockpit ground with numerous impacts of balls and projectiles

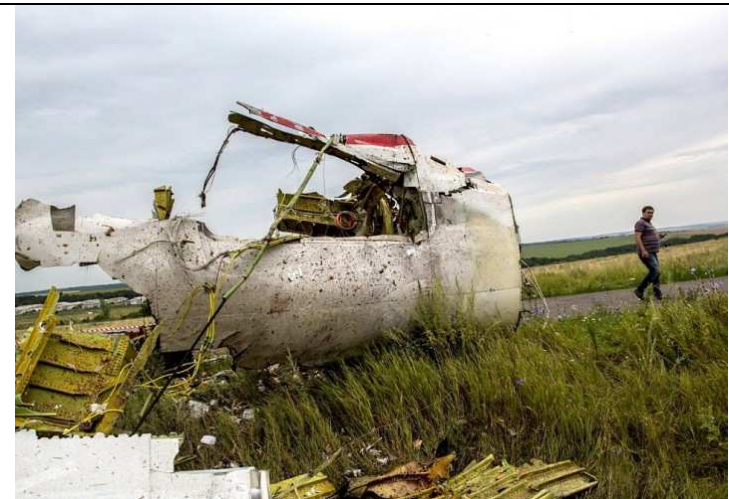
Many small impacts in the tail of the plane – but not to see in the inside

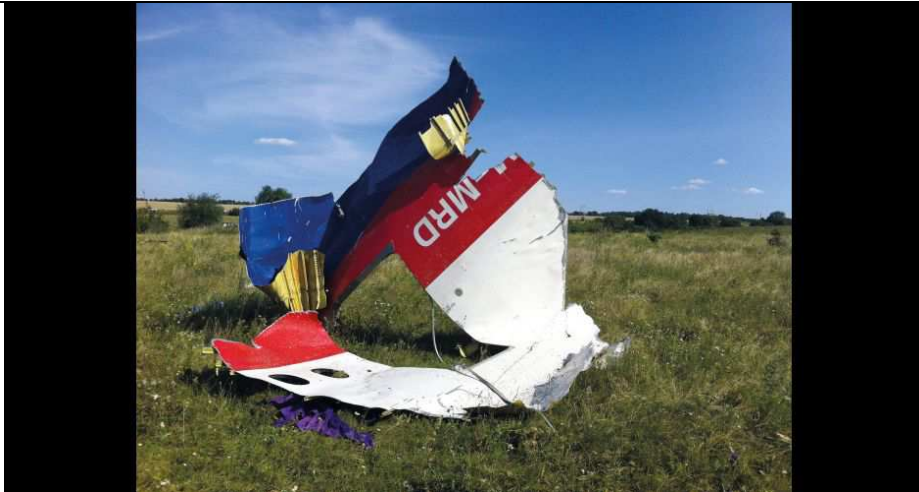
We can't see any proyectil o shrapnell impact

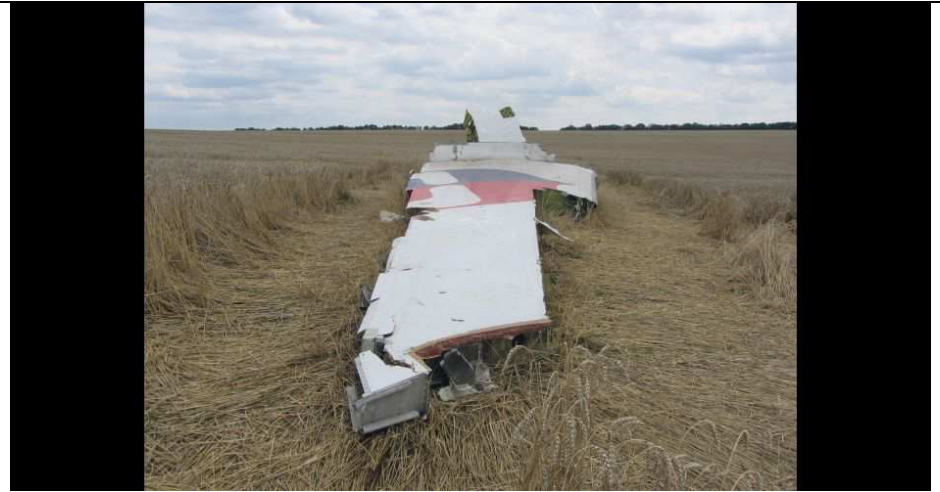
Not any shrapnell impacts

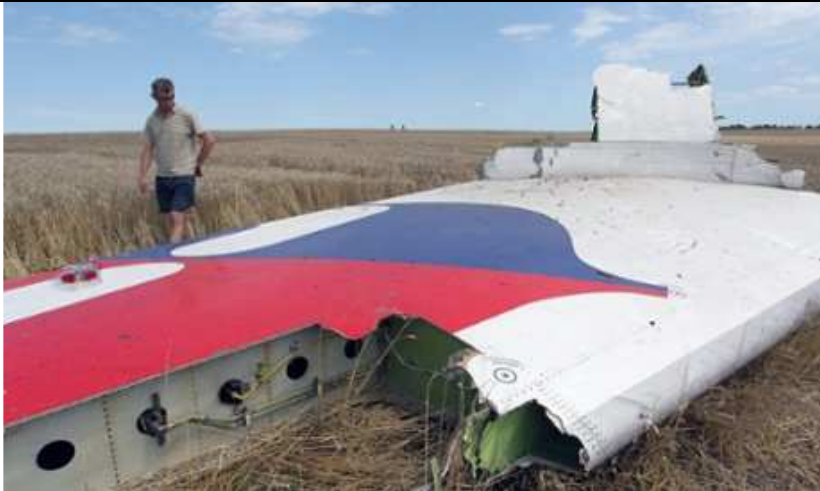
No impacts

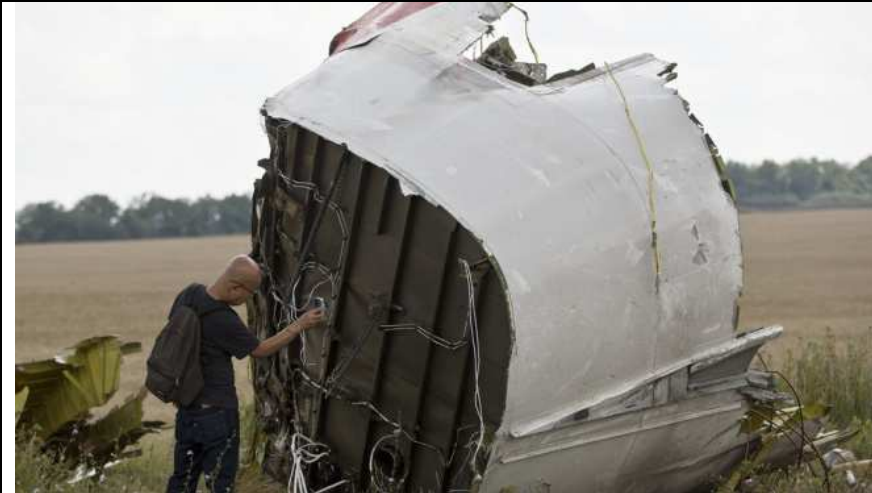
“... The largely intact fragments of the rear sections broke in midair at the weaker points of construction most likely under extreme internal air pressure” (Haisenko)

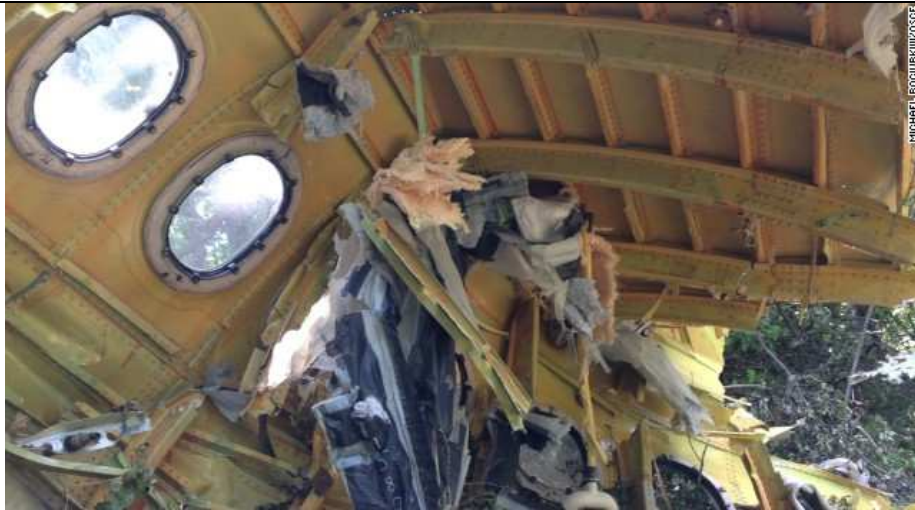
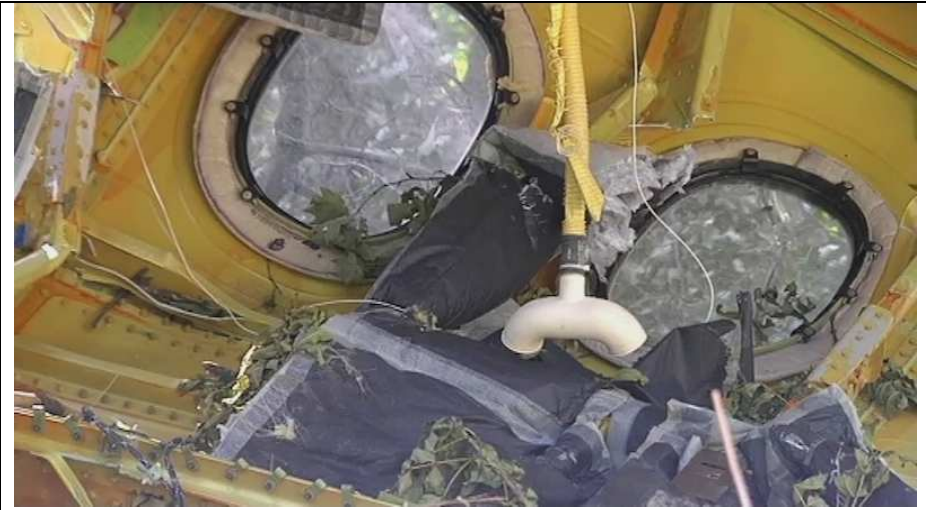
All fragments without any impacts

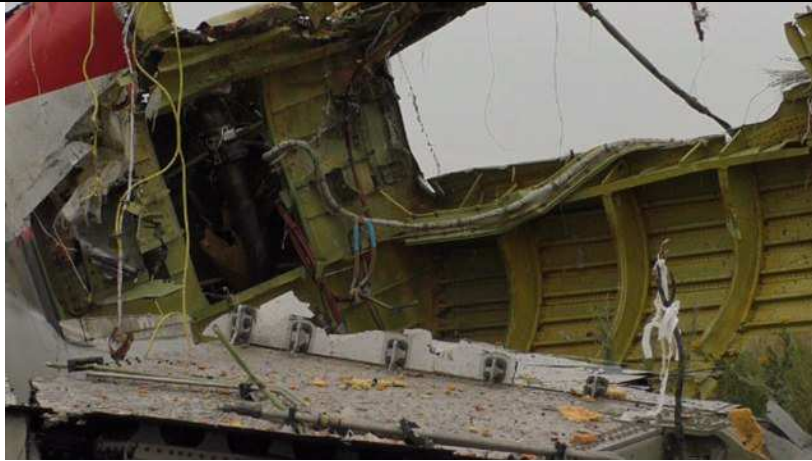
The tail of the plane- inside look. The outside shows many little points-but the inside seems to do not so; there is NO photo of the other side of the tail to find

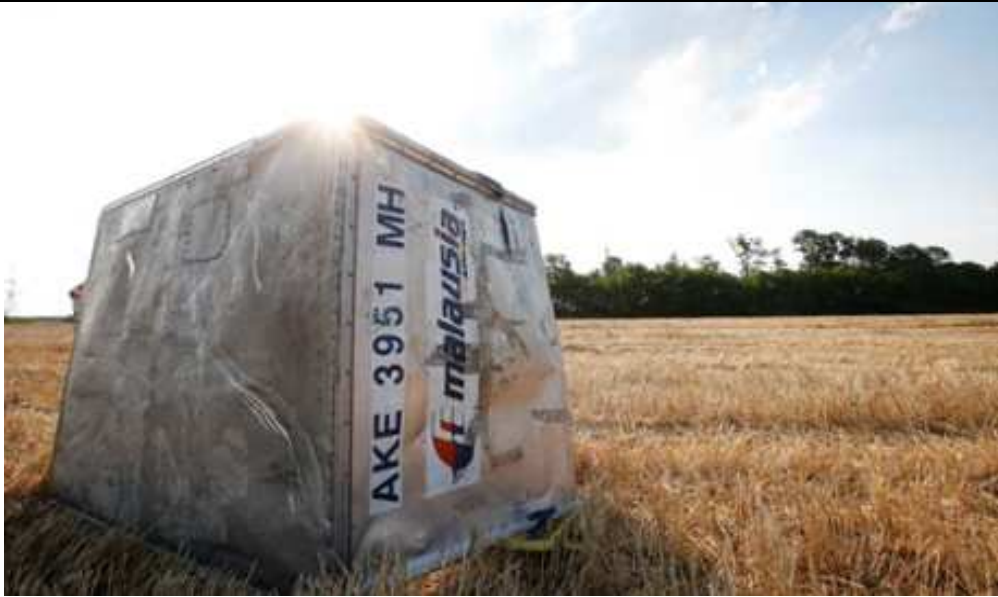
No impacts of shrapnell

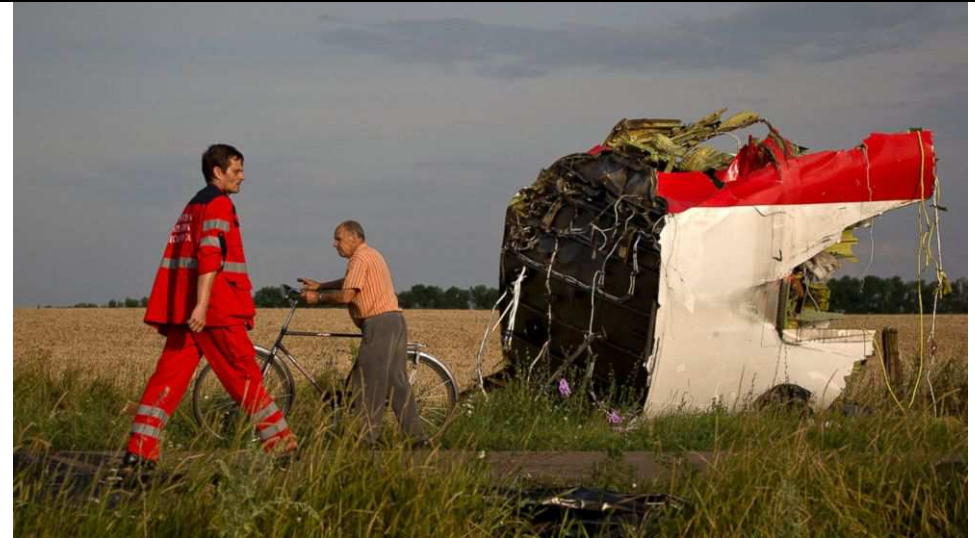
No shrapnell impacts

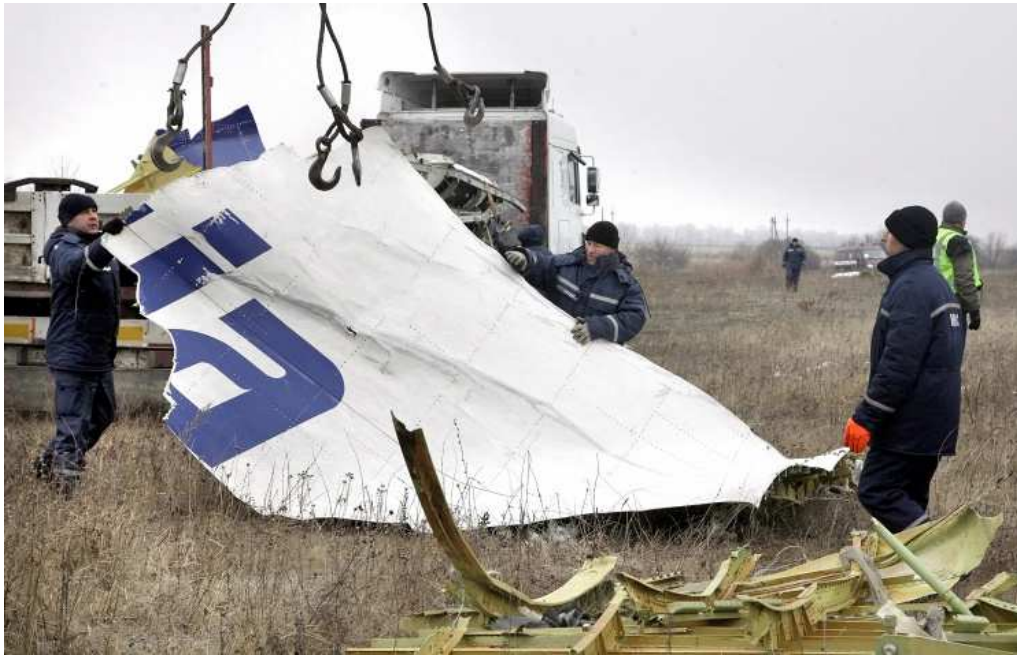
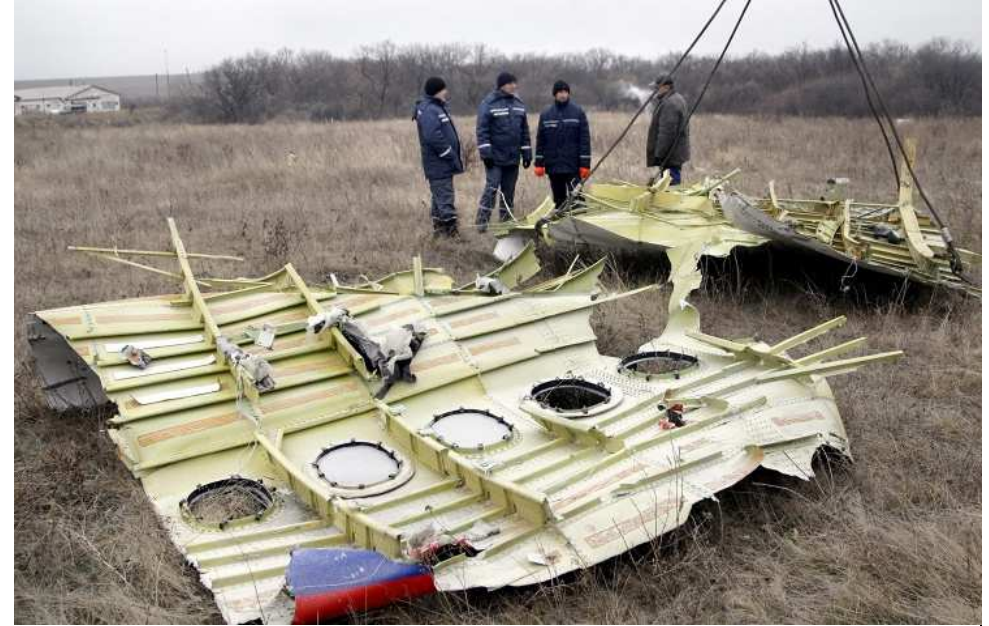
No shrapnell-impacts
